5.0 A Crash Potential #1 (Risk Category E) – Visibility

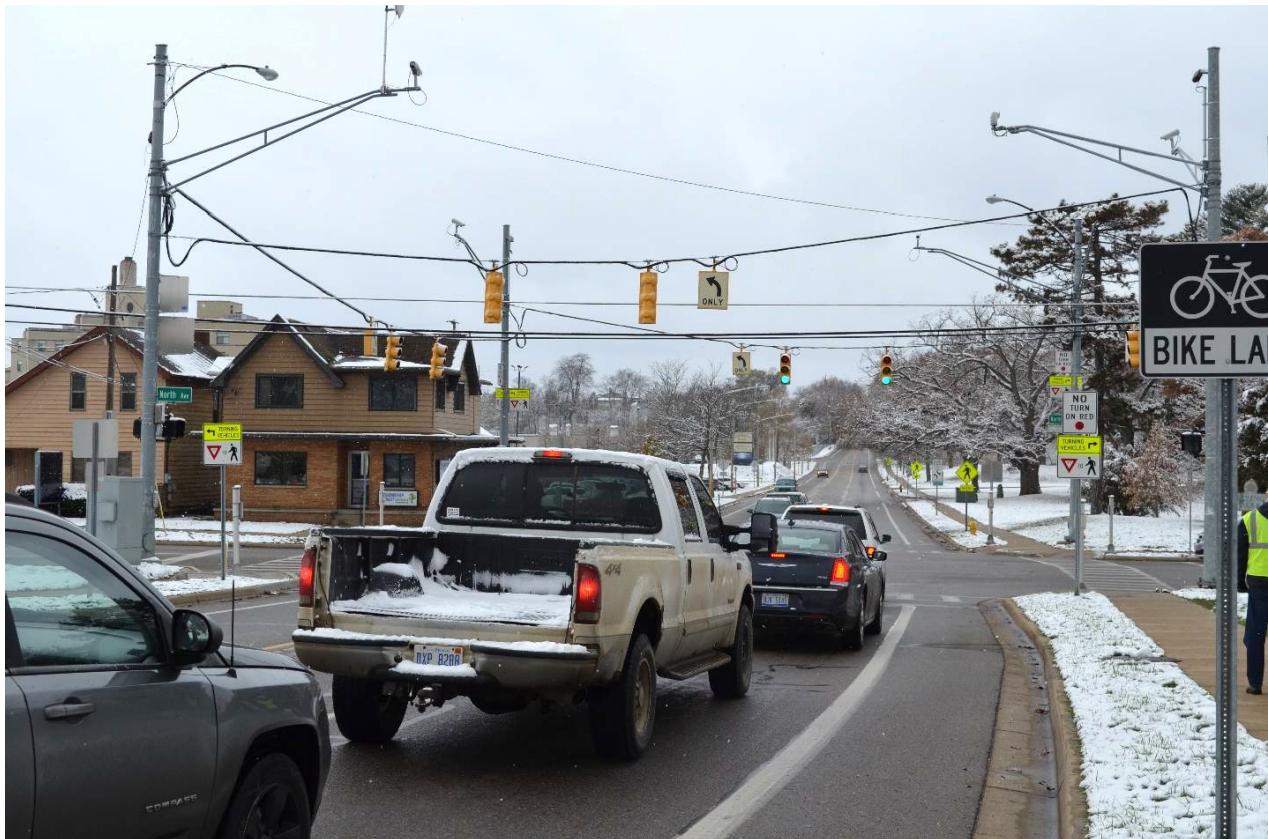
- Sign Overload – there are many signs at and on the approaches to the intersection

- Consider removal of near side “Turning Vehicles Yield to Pedestrians”. As vehicles are waiting to turn left at the intersection, these near side signs are not visible to the driver.

Remove eight near side “Turning Vehicles Yield to Pedestrians” per work order #54932.

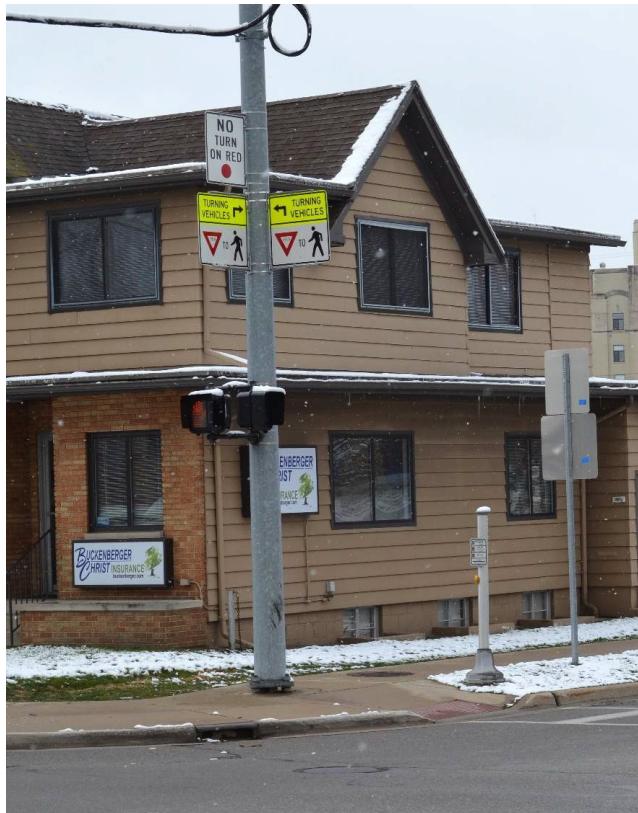
5.1B Crash Potential #1 (Risk Category E) – Visibility

- Sign Placement

- Relocate far right signs, bring down below pedestrian signal heads, raise pedestrian signal heads to maintain 7' bottom height
- Relocate far left signs, place on backside of near right signs
- No Turn on Red signs should be replaced by sign on span wire (static case sign or blank out sign)

MMUTCD requires that the mounting height of a pedestrian signal to be between 7' and 10' (Section 4E.05). The size of "Turning Vehicles Yield to Pedestrians" would not allow this criteria to be met if signs and pedestrian signals were switched. In response to the suggested improvements the eight far side "Turning Vehicles Yield to Pedestrians" will be lowered per work order #54935

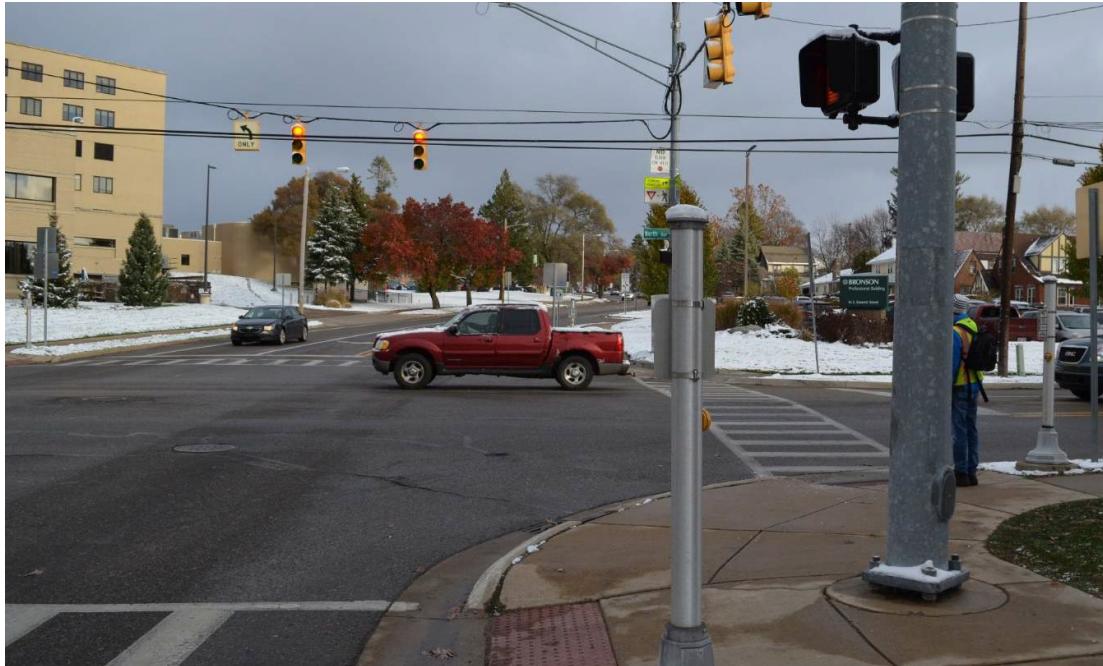
5.1C Crash Potential #1 (Risk Category E) – Visibility

- Utility Lines are in front of signal heads

- Request that the utility company raise their lines on the existing poles
- If signal is rebuilt use tie-offs to float signal heads in front of the utility lines

City staff has requested that ATT investigate a resolution to this situation.

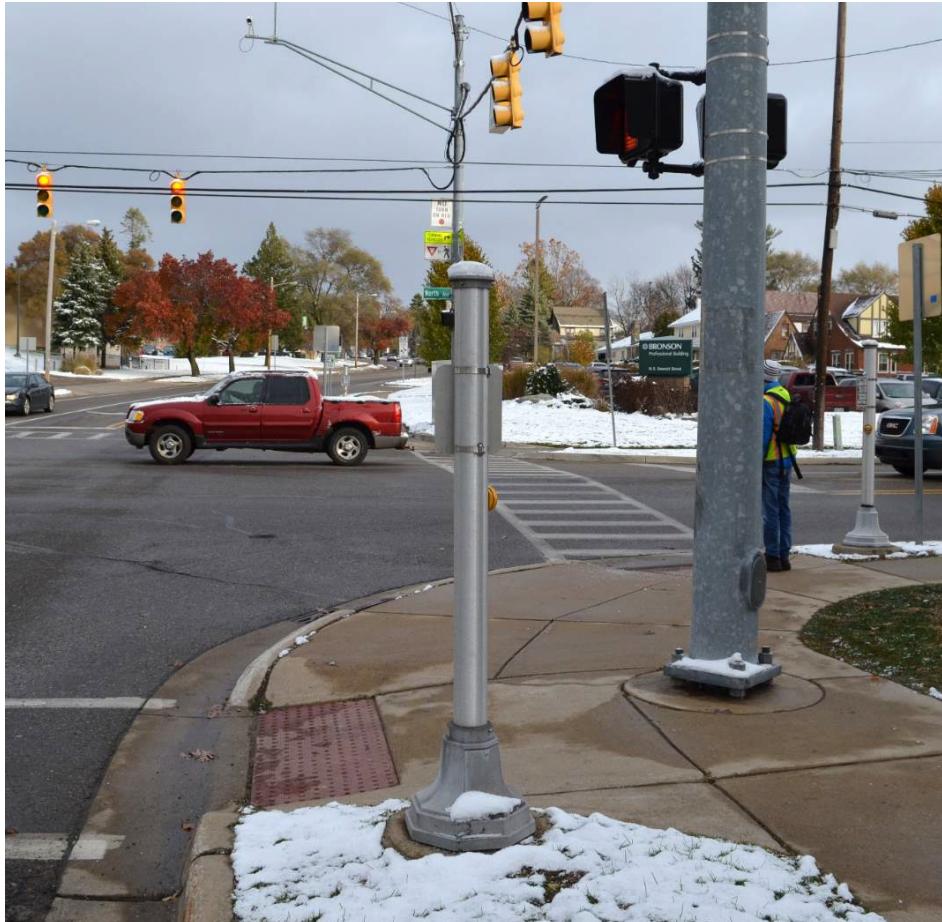
5.1D Crash Potential #1 (Risk Category E) – Visibility

- The strain pole on the SW quadrant can block view of pedestrians from EB traffic

- Relocate the strain pole as part of a signal modernization

The City is not implementing any changes at this time. The existing right of way is insufficient to address this crash potential. The proposed roundabout installation will remove all traffic signal control equipment which will increase pedestrian visibility.

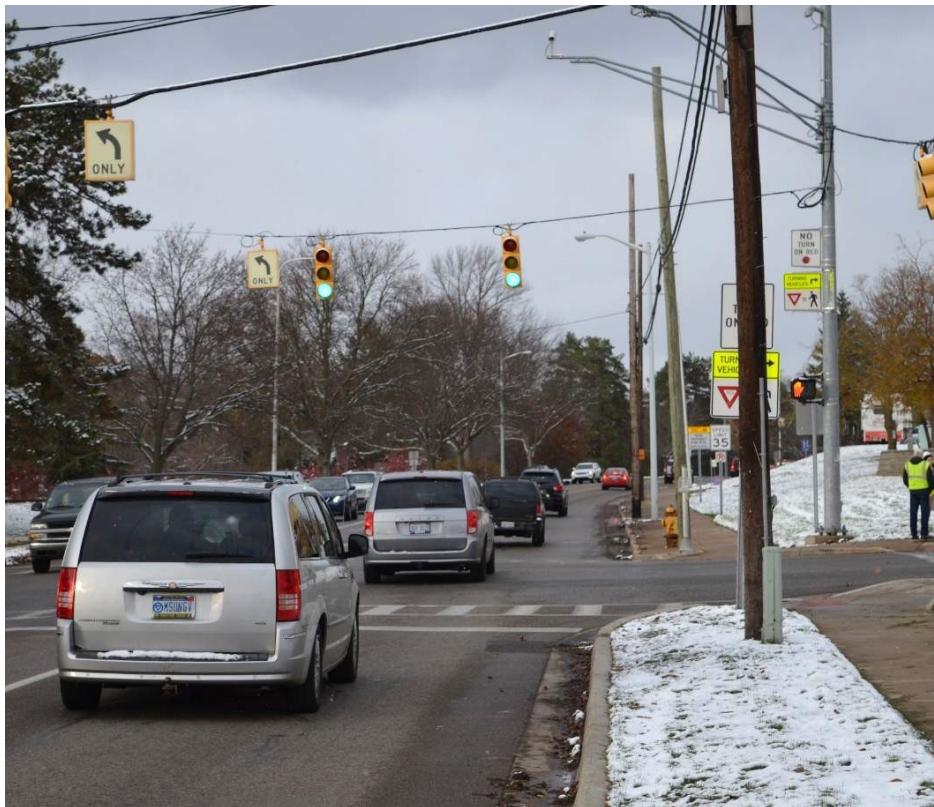
5.1E Crash Potential #1 (Risk Category E) – Visibility

- The utility pole on the NB approach blocks signs at corner

- Move the stop bar back and move signs onto or in front of the utility pole

In response to the suggested improvement the city will relocate the “No Turn on Red” sign in front on utility poll per work order #54938. Stop bar will be relocated away from intersection in the spring of 2019.

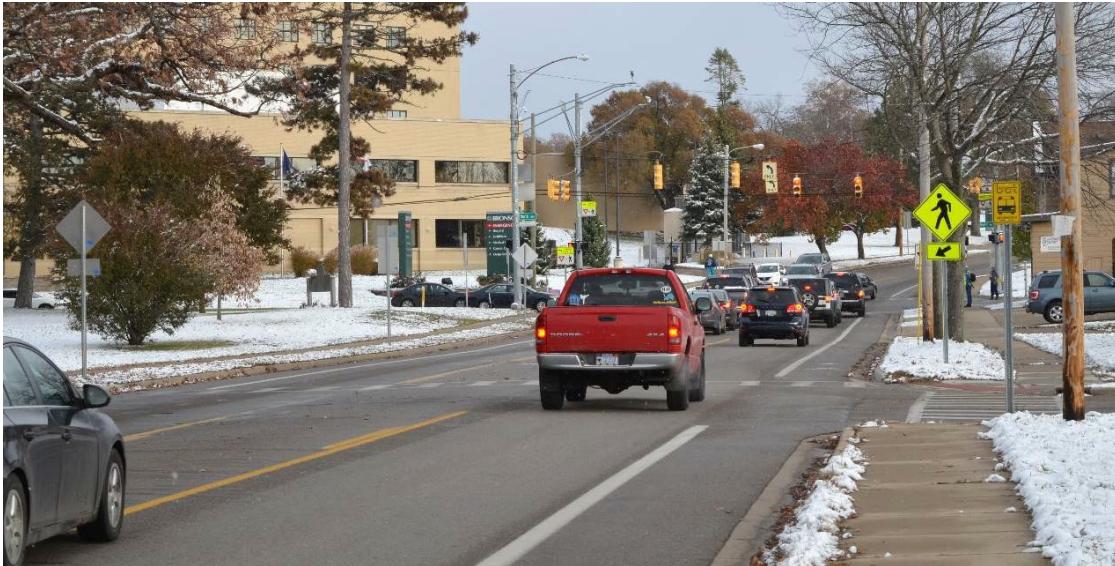
5.1F Crash Potential #1 (Risk Category E) – Visibility

- EB traffic may miss the mid-block pedestrian crossing

- Move the warning sign and diagonal down arrow to near side of intersection
- Upgrade pavement markings
- Reduction of signs at main intersection

City Staff has elected to keep current location of pedestrian warning sign as moving it to the west side of the intersection would require that sign be placed further away from the edge of the road making it less obvious. Pavement marking will be update in the spring.

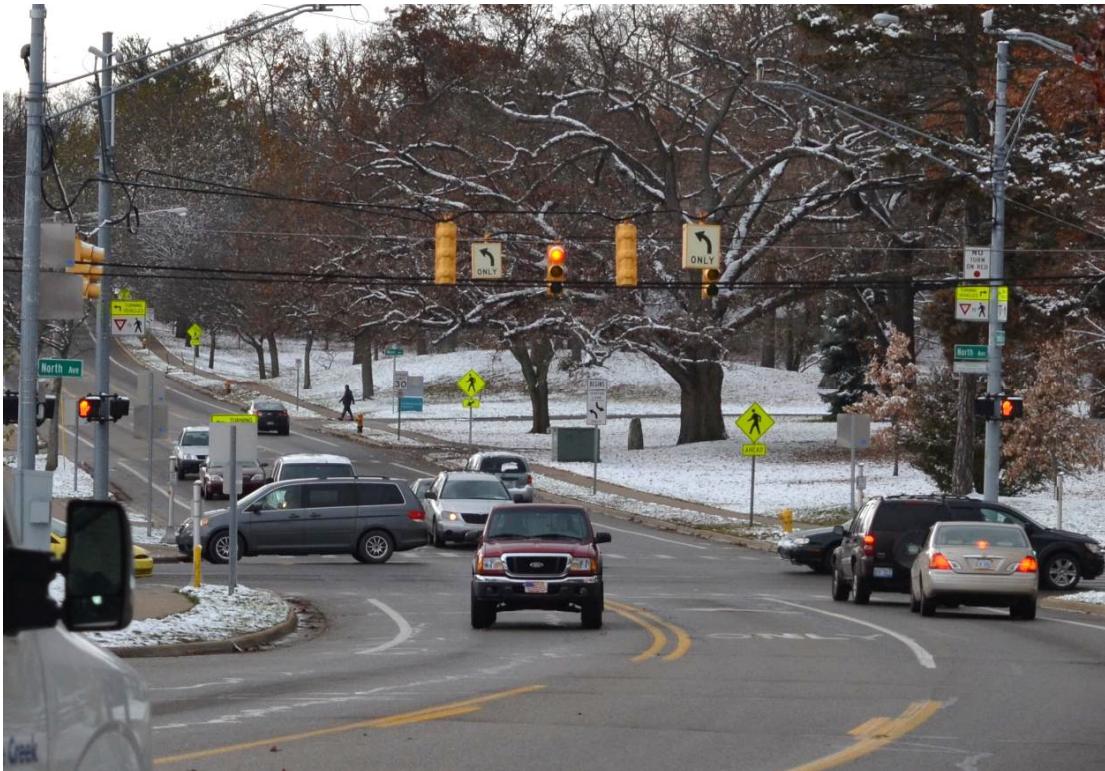
5.1G Crash Potential #1 (Risk Category E) – Visibility

- Near and Far left turn case signs can be confusing or obstruct signal heads

- Use all single sided case signs, eliminating the near side arrow and only
- Re-position case signs and signal heads to provide visibility on all 4 approaches
- Add a low level signal head to far right strain pole (NW quadrant facing east)

Blank backplates will be added to the four case signs per work order #54940. Case signs and signals are placed in accordance with the MMUTCD. Visibility obstruction is a byproduct of the horizontal and vertical curves in the area and is considered minimal and does not warrant additional of low level signal head which could be considered as unnecessary clutter. Roundabout installation will remove all traffic signal equipment visibility obstructions.

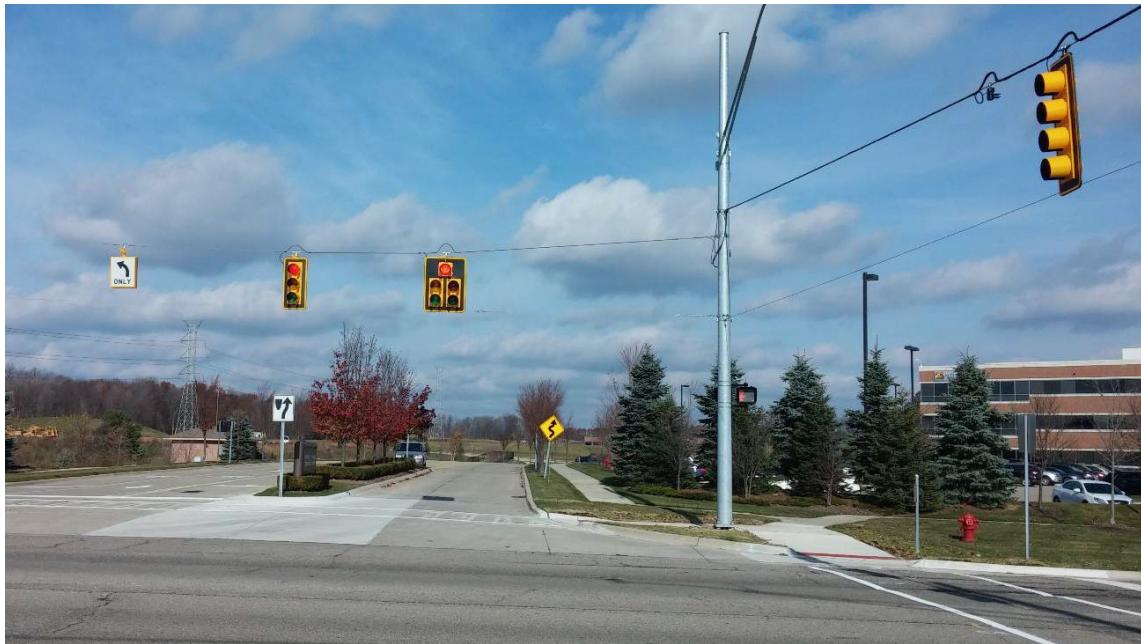
5.1H Crash Potential #1 (Risk Category E) – Visibility

- General visibility of signal heads

- Add tethers and backplates to the signal heads

The City of Battle Creek will add tethers and backplates as per work order #55185

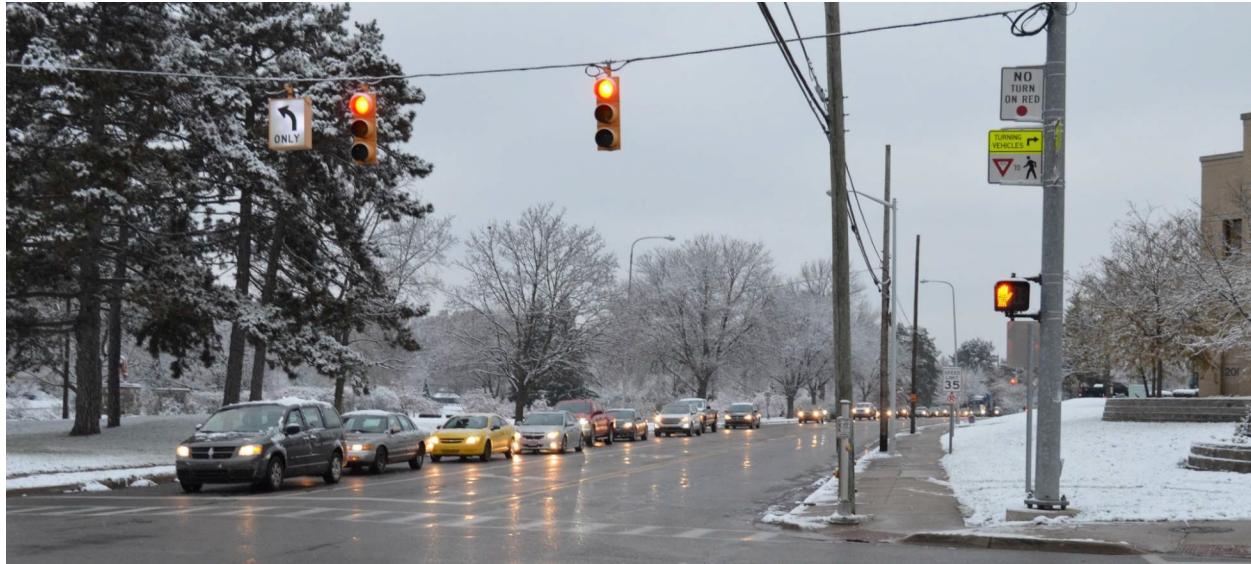
5.2A Crash Potential #2 (Risk Category E) – Signal Timing

- There is a short cycle length of 60 seconds throughout the day leading to long queues during peak hours
- Pedestrians using the west leg conflict with SB right turns causing only 2-3 vehicles to get through on green

- Revisit city's modeling to make sure that pedestrians are accurately represented in the models
- Increase the cycle length
- Add a leading pedestrian interval to get peds started while traffic is held under all red phase

The City of Battle Creek's engineering staff revisited the model and determined that a longer cycle length and leading pedestrian interval would lower the overall level of service from a B/C to a C/D. This was to be acceptable and new control equipment will need to be installed to accomplish this improvements.

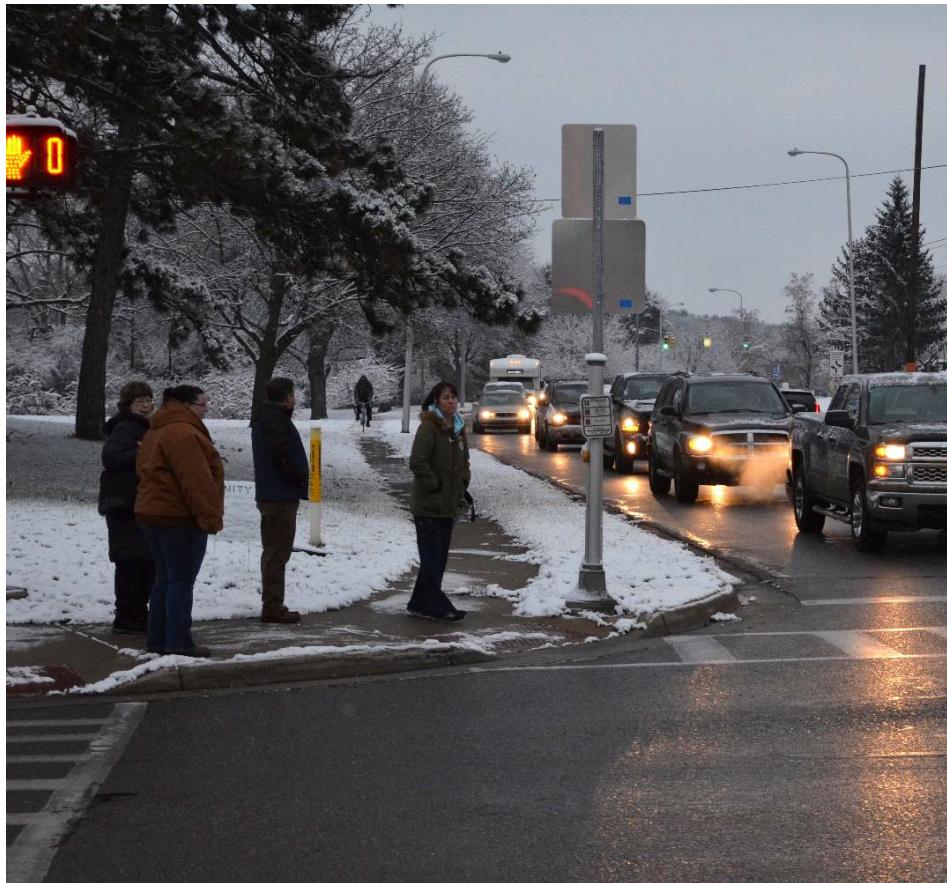
5.2B Crash Potential #2 (Risk Category E) – Signal Timing

- Pedestrian crossing times may be too short based on latest standards
- Pedestrian pushbuttons only turn on walk for one leg at a time

- Re-evaluate the pedestrian crossing times using the MDOT clearance interval spreadsheet
- Consider putting pedestrians on recall during peak periods, need to push the button the rest of the day
- Program the signal to turn on the parallel walk leg when a pushbutton is pressed

The Pedestrian timing will be adjusted as suggested by MDOT during the controller upgrade and leading pedestrian interval programing. The pedestrian recall is not being pursued due to a fear of pedestrian during non-peak times failing to use the push buttons. This may be revisited in the future if detailed pedestrian counts are taken. Similarly the parallel walk activation is not being pursued due to the possibility of delayed pedestrian crossings a situation that will be addressed with the leading pedestrian interval.

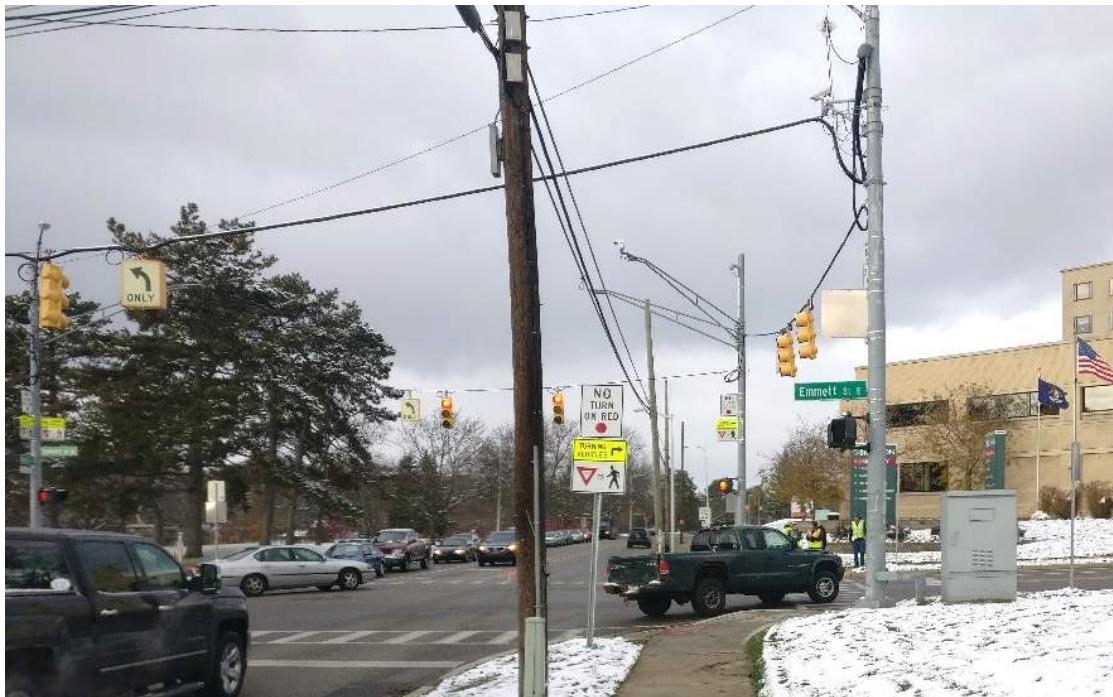
5.3A Crash Potential #3 (Risk Category D) – Non-Compliance

- Vehicles turning on red

- Improve visibility
 - Align signs with drivers vision
 - Relocate signs to spans
 - Blank out signs
 - Reduce sign clutter
- More enforcement

With the addition of tethers the “No Turn on Red” signs that are currently located on the strain poles will be relocated to the span per Work order #55186. Report was also shared with the Battle Creek Police Department for enforcement consideration.

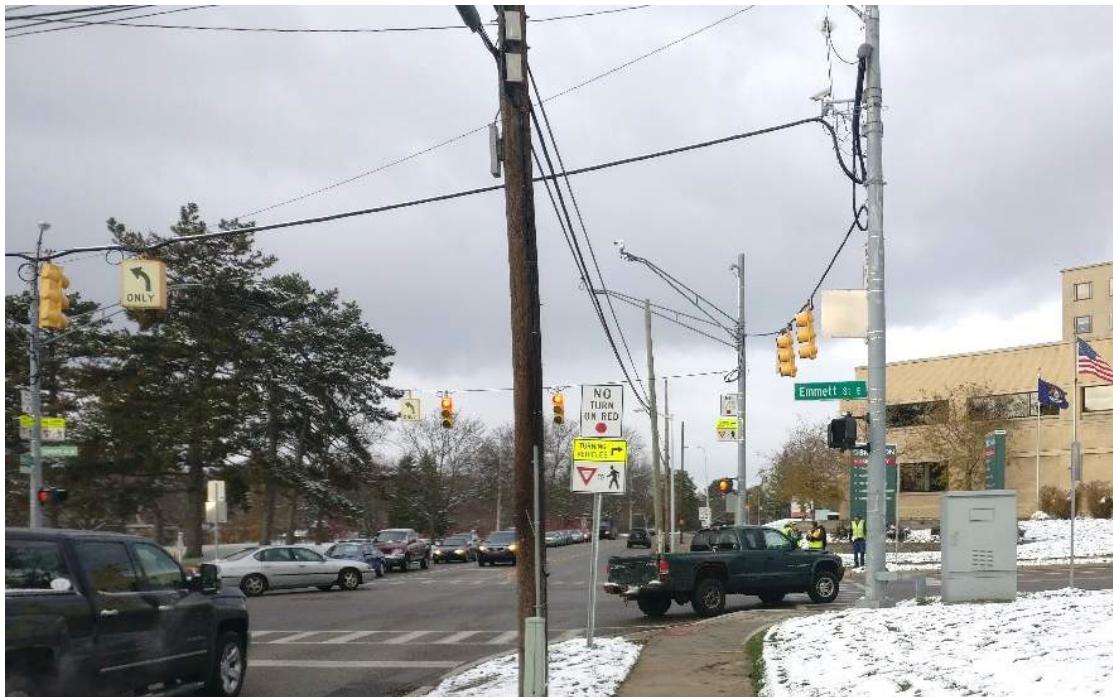
5.3B Crash Potential #3 (Risk Category D) – Non-Compliance

- Red light running

- Update signal clearance intervals
- Add backplates to improve signal head visibility
- Increase cycle length

Signal control will be upgraded to allow a leading pedestrian interval and longer cycle length and clearance intervals per Work order #55187. Backplates will be installed per work order #55185.

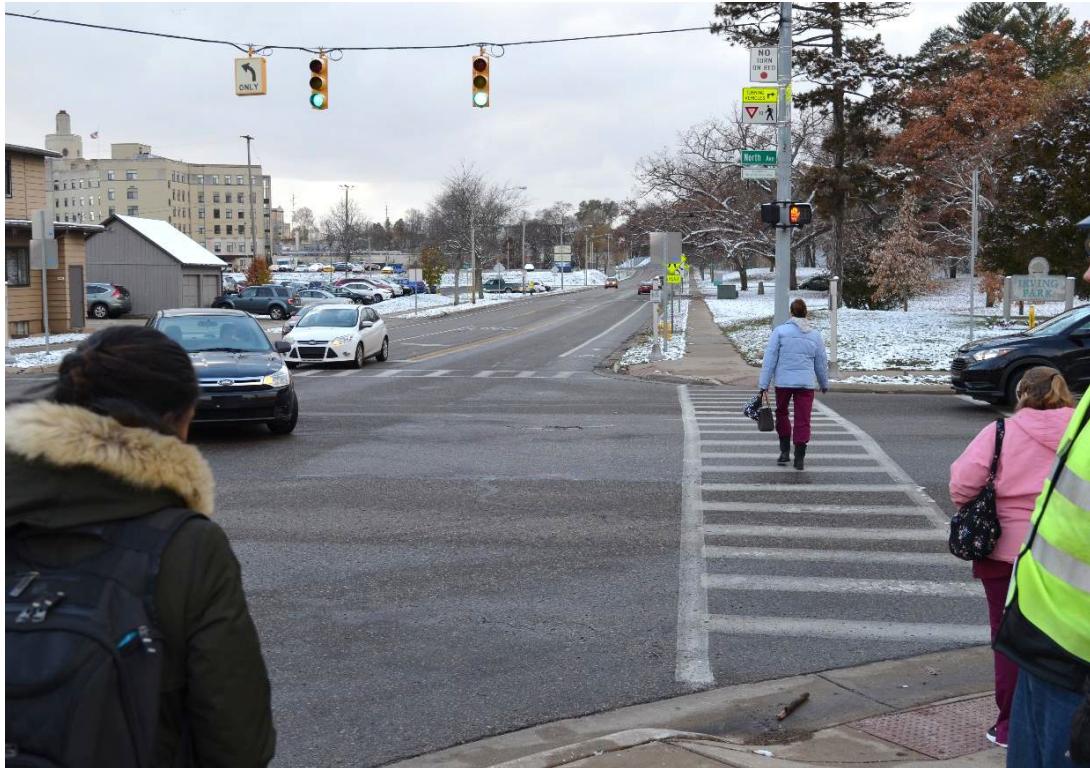
5.3 C Crash Potential #3 (Risk Category D) – Non-Compliance

- Pedestrians not pushing the pushbuttons

- Modify signal controller to turn on parallel ped signal with activation
- Turn on pedestrian recall for peak pedestrian periods
- Perform maintenance on SE corner pushbutton mounted to strain pole, not always working

Signal control will be upgraded to allow a leading pedestrian interval and longer cycle length and clearance intervals per Work order #55187. Pedestrian observation will be made to determine if parallel pedestrian signal activation is needed. Detailed pedestrian counts were requested as part of the 2019 Multi-modal counts which may help with determining if pedestrian peak recall is needed.

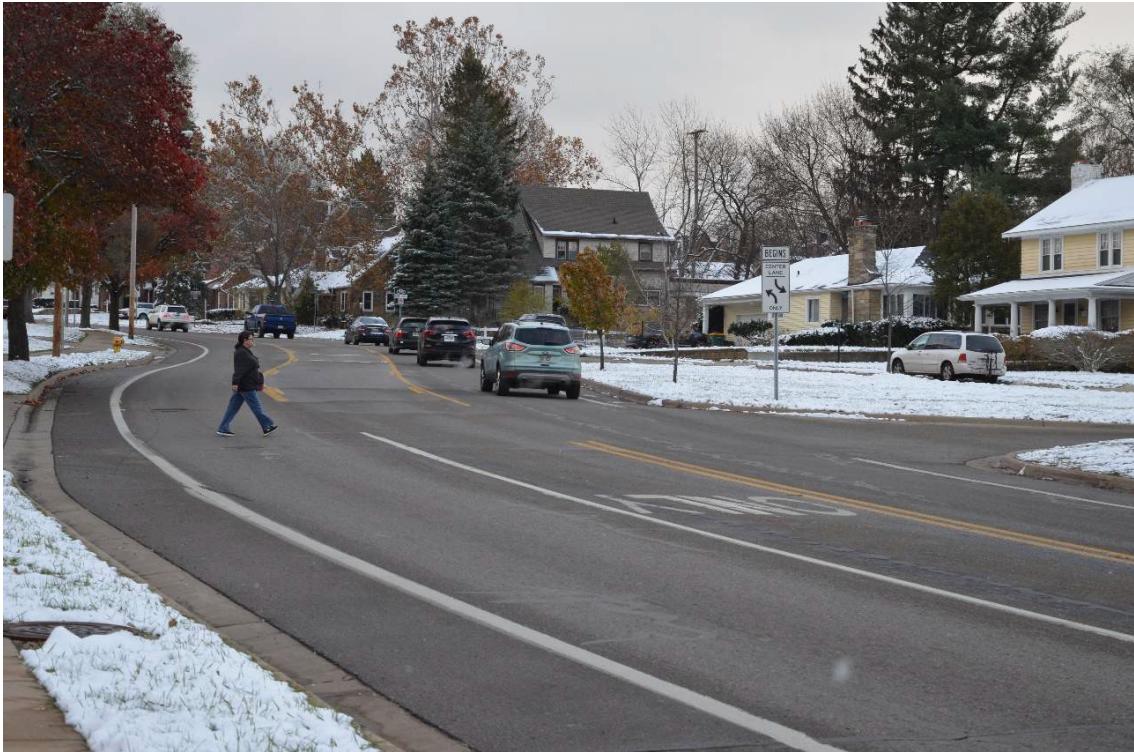
5.4 A Crash Potential #4 (Risk Category D) – Driver expectation

- Pedestrians crossing at unmarked crosswalks away from intersection

- Issue a TCO and install signs to prohibit crossing at Emmett Loop intersection
- Add fences to discourage crossing
- Restrict employee use of loading zone doors

No Action. It was determined that compliance and enforcement of the recommended TCO unlikely and a fence installation could create more of a hazard. Staff will continue to work with Bronson to encourage staff to only use legal crosswalks.

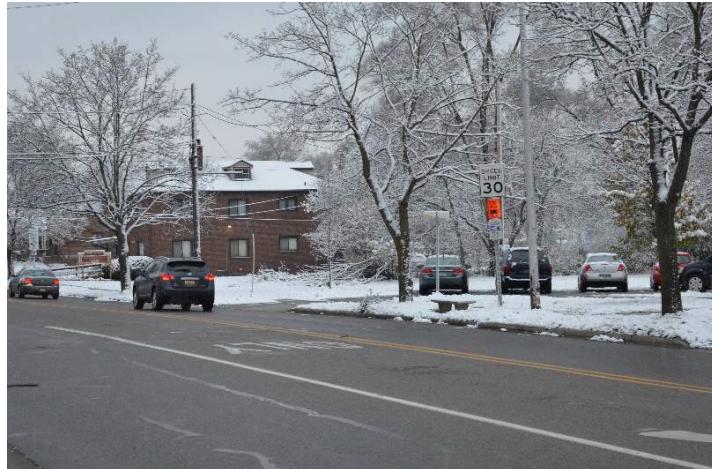
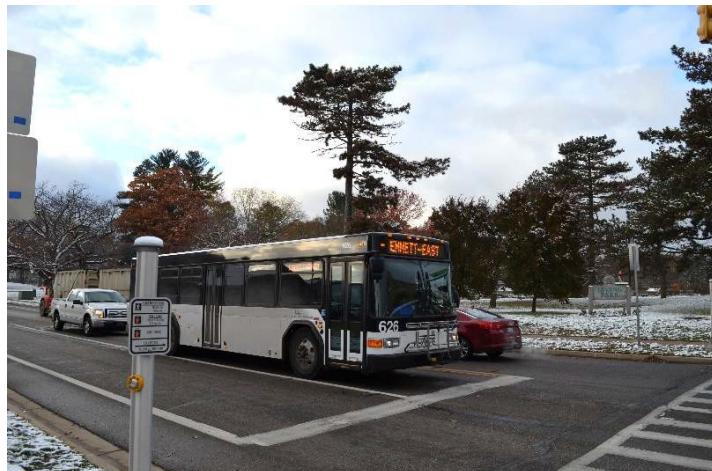
5.4B Crash Potential #4 (Risk Category D) – Driver expectation

- Bus stops near the intersection

- Review need for bus stop sign since the transit route map does not show the south leg as a stop

Three bus stops were evaluated with Battle Creek Transit leadership. Work order #54663 was issued to relocate the stop located at 285 North Ave and Work order #54664 was issued to relocate the stop located at 300 North Avenue further away from the intersection. Work order #55126 was issued to remove the stop located at Emmett St W and College St.

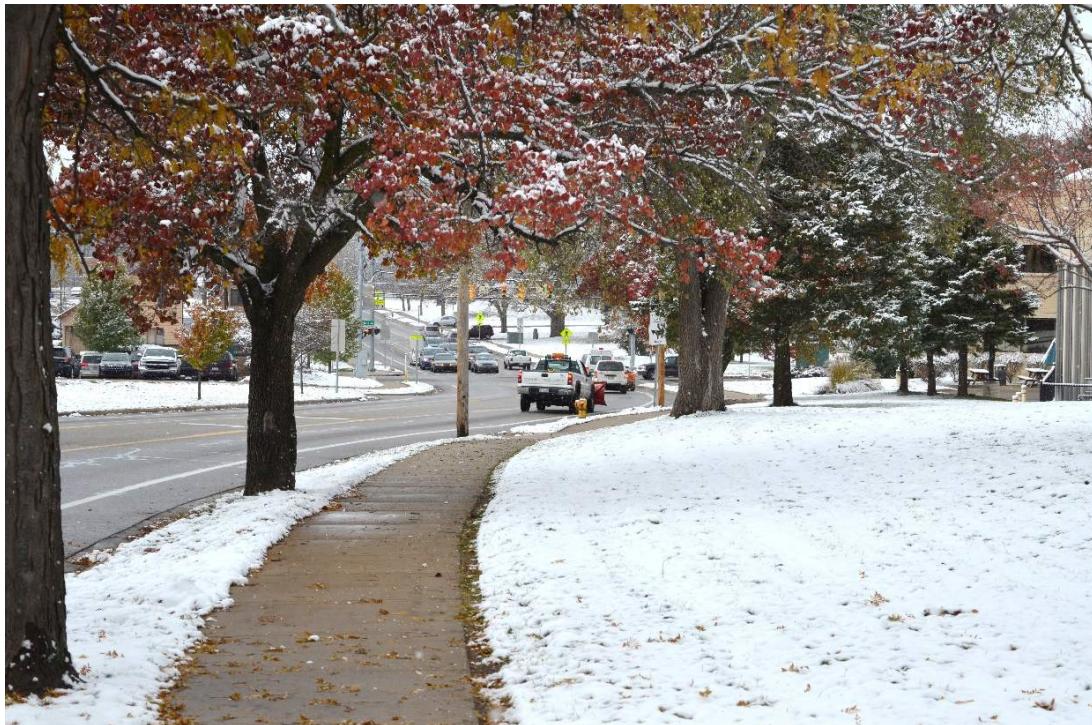
5.5 Crash Potential #5 (Risk Category C) – Geometrics

- The north and east legs have horizontal curves approaching the intersection, inhibiting sight distance to the signal
- The east leg also has a vertical grade change

- Realign east leg of the intersection to smooth out the curves
- Consider high friction pavement on east leg
- Review clearance intervals with respect to grades
- Add low level signal head in northwest quadrant facing east

Suggested improvements will be considered if it is determined that a roundabout installation is not feasible which could incorporate alignment changes, high friction pavement and the elimination of all traffic signal equipment.

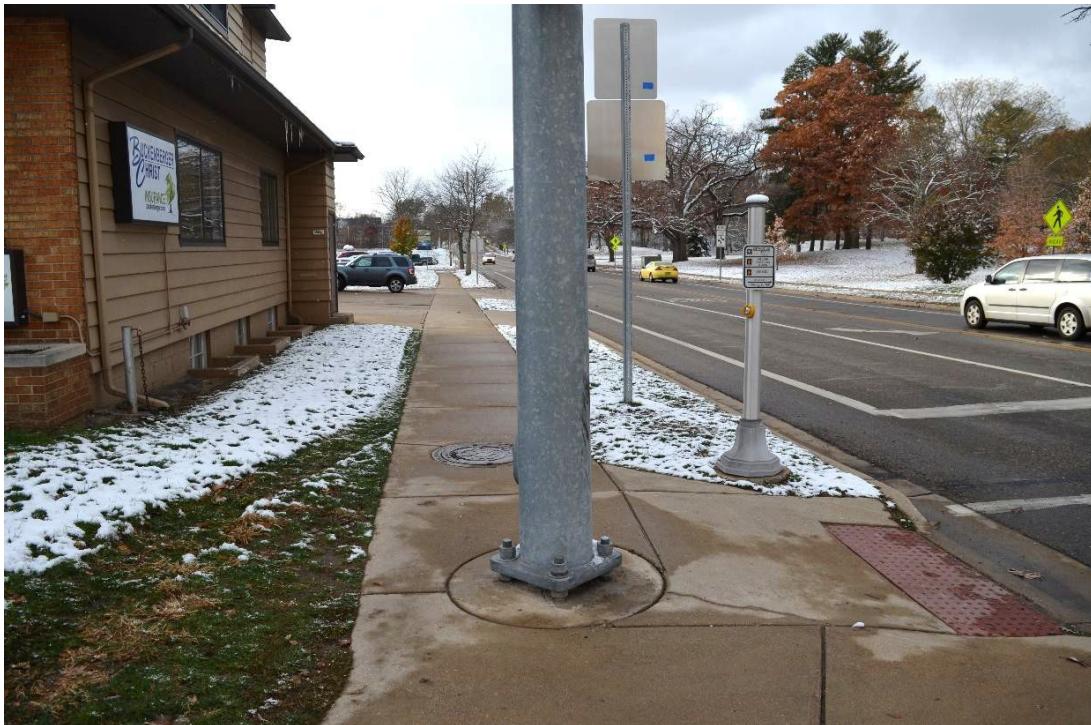
5.6B Crash Potential #6 (Risk Category B) – ADA Ramps and Sidewalks

- Strain pole located in the middle of the sidewalk

- Obtain an easement to provide full width sidewalk around the pole or relocate pole as part of a signal modernization

Easement and relocation of strain pole will be considered if roundabout solution is considered not feasible which would remove all existing traffic signal control equipment.

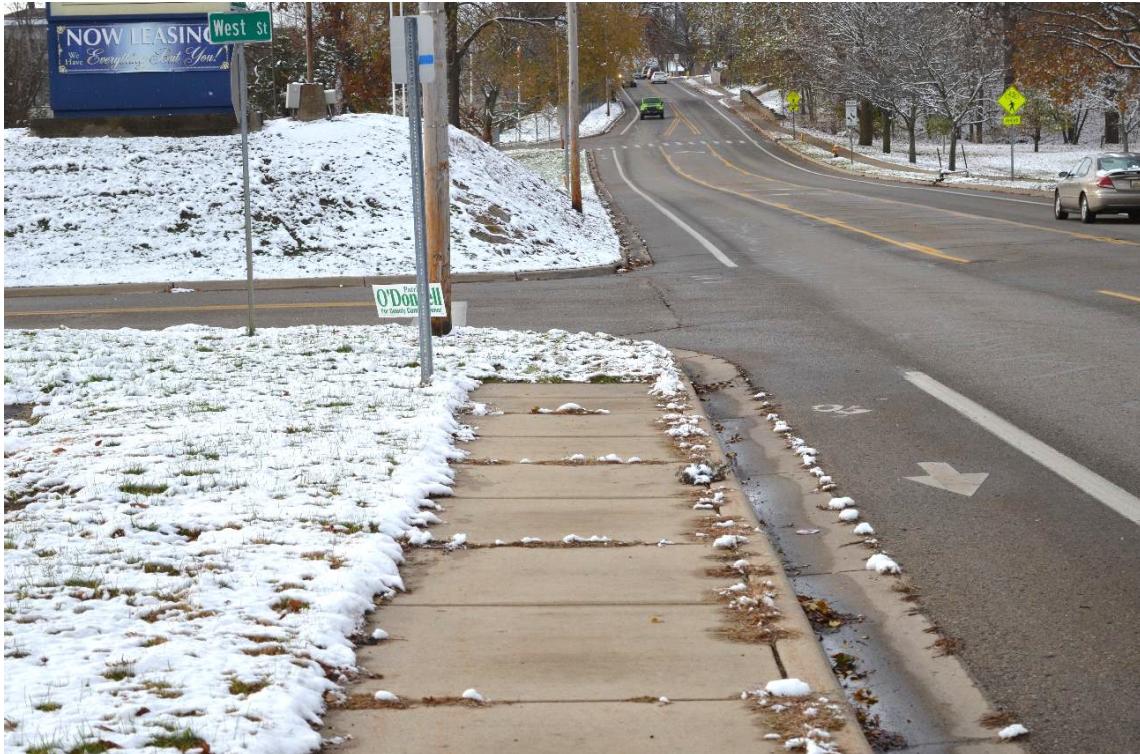
5.6C Crash Potential #6 (Risk Category B) – ADA Ramps and Sidewalks

- Sidewalk abruptly ends along south side of Emmett at West Street

- Provide a pedestrian crossing of Emmett at West Street

No action. Cost of extending the sidewalk to the Linear Park would require retaining wall to be constructed. Sidewalk serves as a collector for Bronson's Employee parking lot which makes removal not practical. Bronson indicated that some fence may be installed around the existing parking lot. If this is the case the City/Bronson may consider improvements to this section of sidewalk to better serve the new demands.

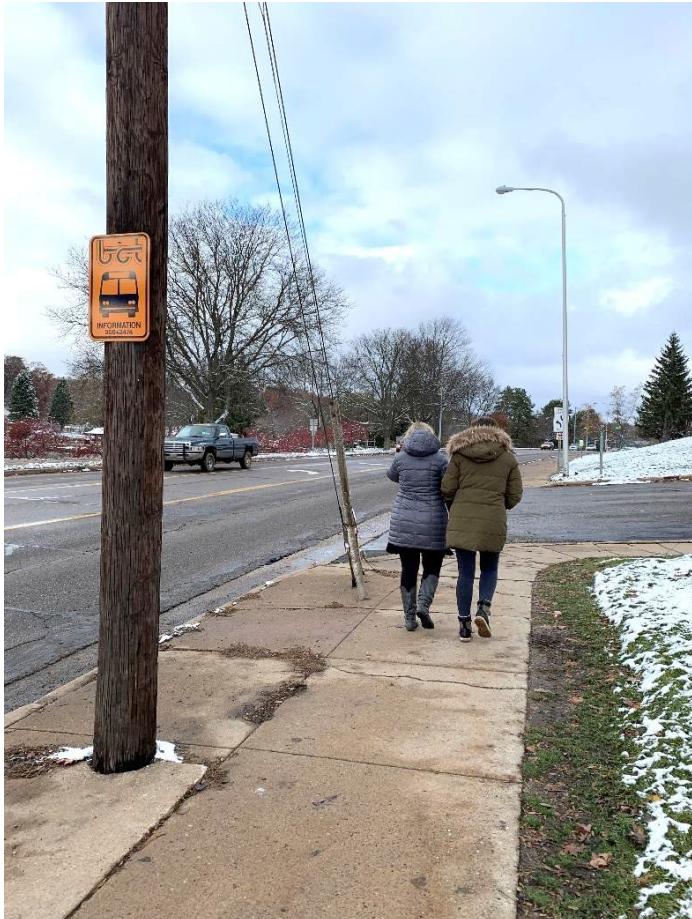
5.6 D Crash Potential #6 (Risk Category B) – ADA Ramps and Sidewalks

- On the north leg, east side of road there is a guy wire missing a protective guard

- Add guy guards

City staff contacted Comcast to repair infrastructure in the area and add guy guard.

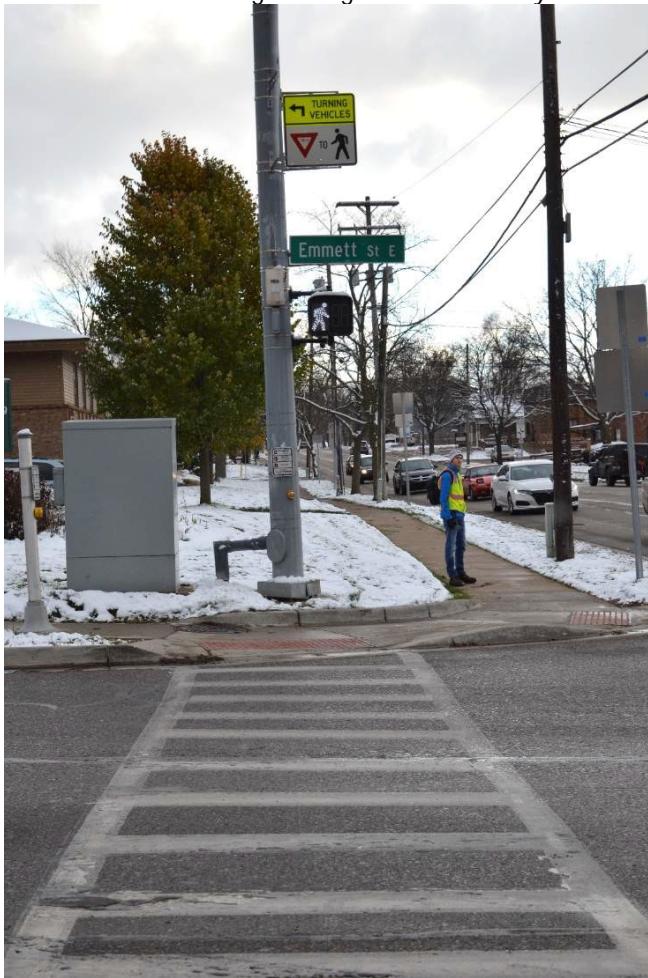
5.7A Crash Potential #7 (Risk Category B) – Pavement Markings

- Pavement marking lacking retroreflectivity

- Upgrade all markings with new thermoplastic
- Recess the special markings
- If a financial issue, prioritize crosswalks, stop bars and then long lines
- If choosing to use waterborne applications, apply twice per year
- Maintain markings using in-kind materials (don't mix materials)

Pavement marking will be upgraded per attached pavement marking detail.

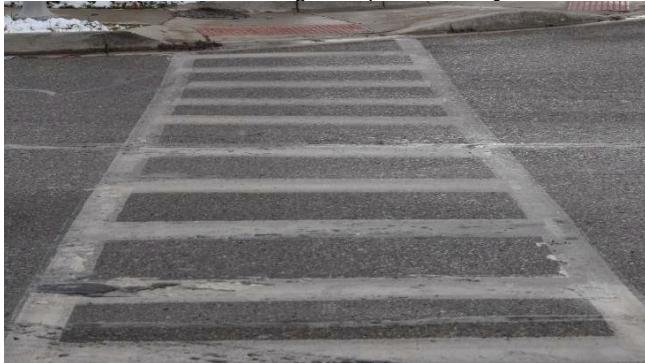
5.7B Crash Potential #7 (Risk Category B) – Pavement Markings

- The crosswalks are high emphasis but just the minimum width

- To provide greater emphasis, widen markings to a minimum 8' as shown below

Pavement marking will be upgraded per attached pavement marking detail.

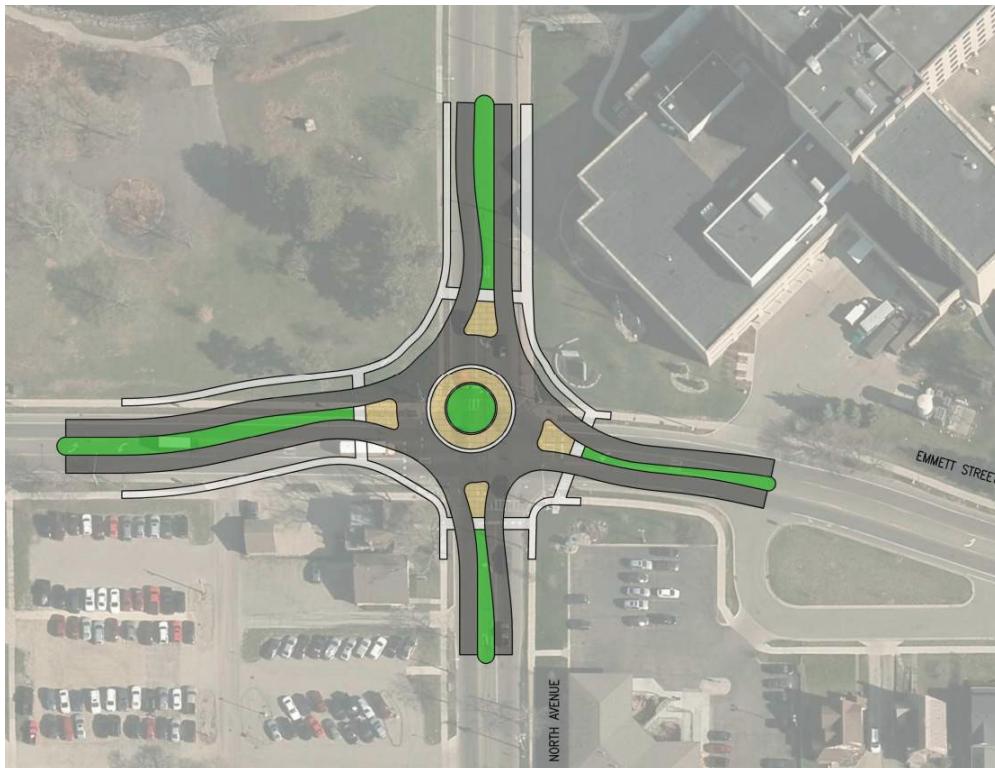
Long Term Recommendation - Roundabout

- Many pedestrians are crossing at all legs of the intersection
- Traffic volumes are relatively even on all approaches
- Right of way on 3 out of 4 quadrants are owned by stake holders (Bronson Battle Creek Hospital -SE and NE, City of Battle Creek NW)

- Construct a single lane modern roundabout in place of the signalized intersection
 - o According to MDOT's crash reduction factors a roundabout provides a 78% reduction in fatal and injury crashes and a 57% reduction in minor crashes.
- Include splitter islands wide enough to shelter pedestrians

City staff have begun to reach out to neighboring agencies that have had success with roundabout installation. Site visit is scheduled with Washtenaw County Road Commission to discuss design elements, public relations strategies and cost. Staff has also began grant funding research and has conclude that project would be eligible for the Michigan Department of Transportation (MDOT) Congestion Air Quality Mitigation grants as well as MDOT Safety Program grants as early as fiscal year 2021.

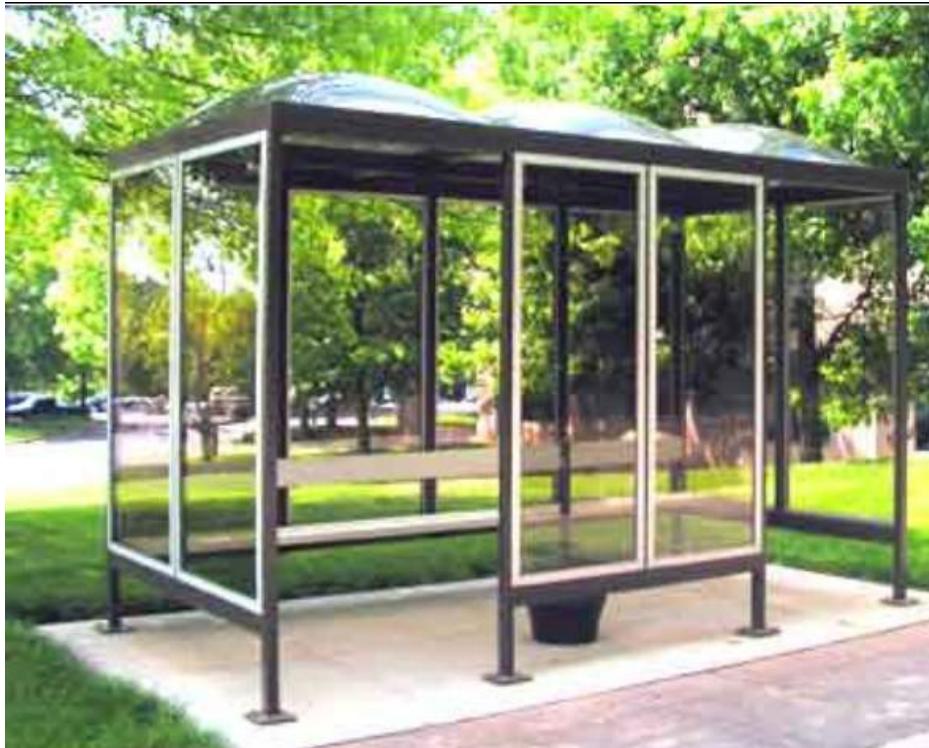
Bus Shelter

- Many pedestrians are crossing at all legs of the intersection

- Consider the addition of a shelter in shuttle lot to promote use
- Encourage car-pooling to reduce parking demand of offsite lots

Suggested was shared with Bronson Leadership as part of the Road Safety Audit wrap up meeting.

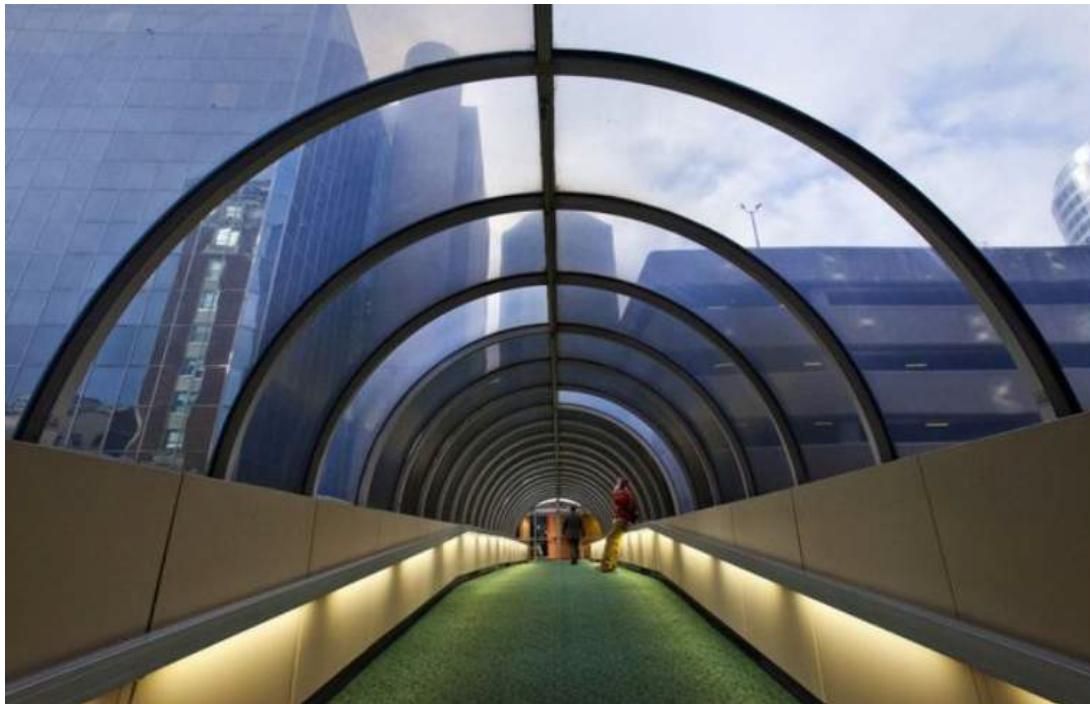
Tunnel

- Many pedestrians are crossing at all legs of the intersection

- A pedestrian tunnel above ground or underground would limit exposure of pedestrians to vehicle traffic

Anticipated cost and level of use does not make this a viable option. Additionally the soil conditions in the area and elevated ground water could make this solution not feasible.

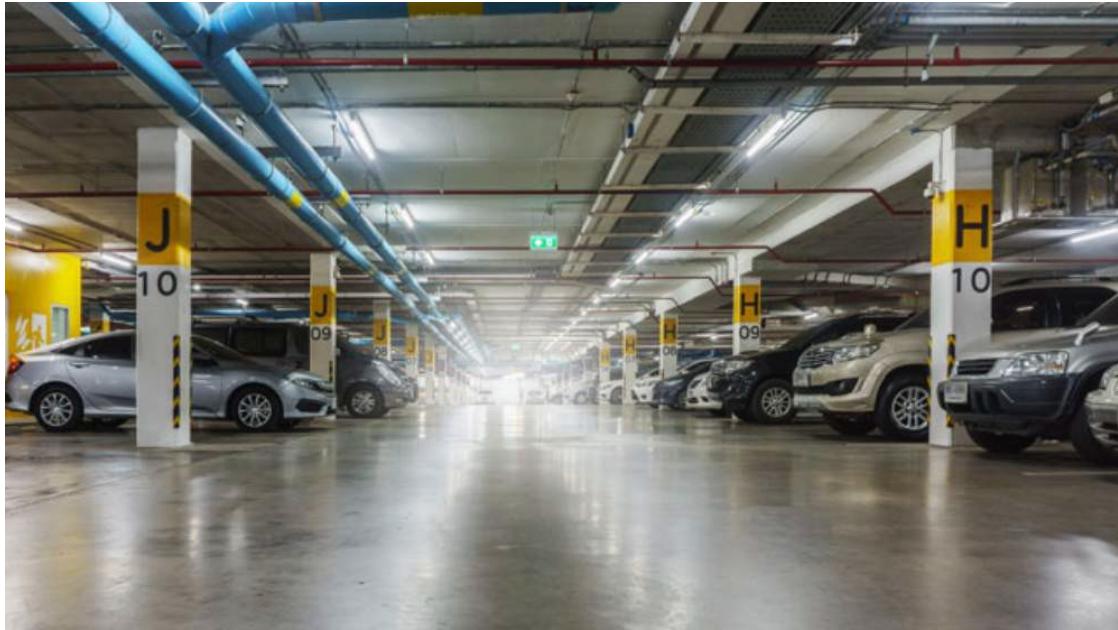
6.4 Parking Garage

- Many pedestrians are crossing at all legs of the intersection

- A parking garage would provide additional parking spaces adjacent to the hospital and limit exposure of pedestrians to vehicle traffic

Anticipated cost and level of use does not make this a viable option. Additionally the soil conditions in the area and elevated ground water could make this solution not feasible.
